The Significance of Defects in CFRP Bonded Honeycomb Structures
and Non-Destructive Test Methods for Their Destruction

R. L Crocker, et al

Fulmer Research Institute
Stoke Poges, England

May 1978

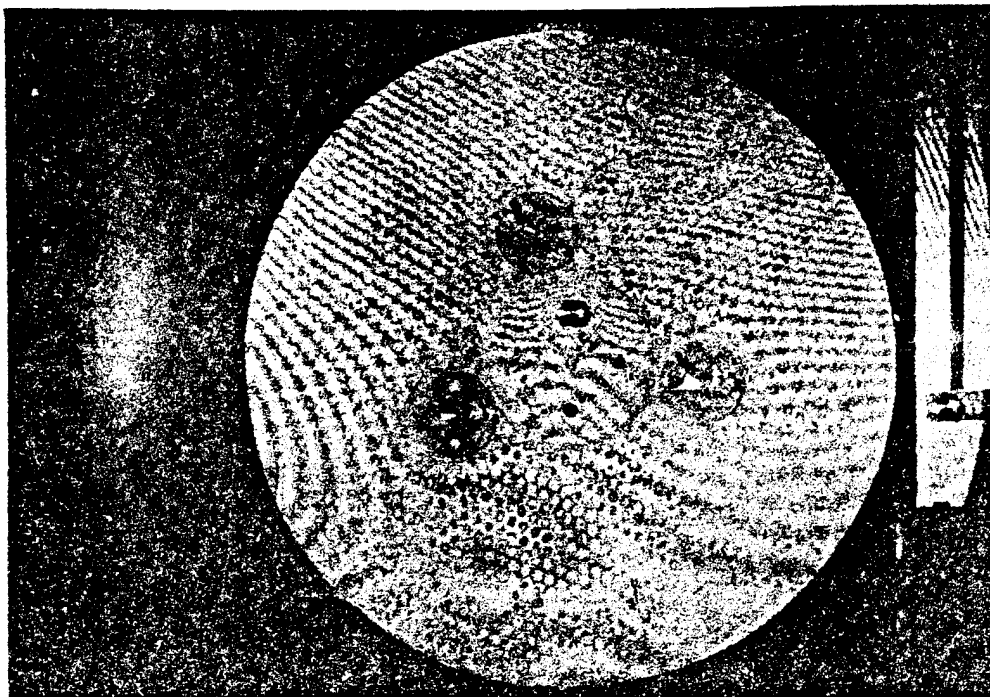
Figure 28 An interferogram of a CFRP/Al honeycomb dish specimen and its superimposed holographic image. Four circular areas of perturbed fringe pattern can be seen and right of centre towards the lower edge of the dish, the fringe pattern caused by hole cut in the skin/core film adhesive is visible.

Note the visualisation of the honeycomb cells, and also the regular fringe pattern on the stand to the right of the dish. Closely spaced fringes around the central fixing bolt indicate an area of high strain. (Sections 3.6 and 5.1.7.)
